Manhole Inspection Summary

Manhole # S13SS1006MH

Insp Date: **11/10/06 11:26 AM**

Location Address: **2525 BELVEDERE AVE** Cross Street: **LEVINDALE RD**

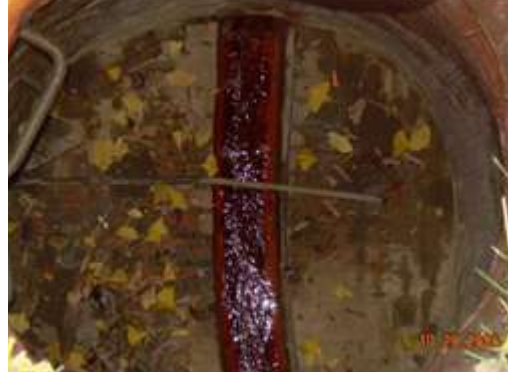
Top View

Bench debris.

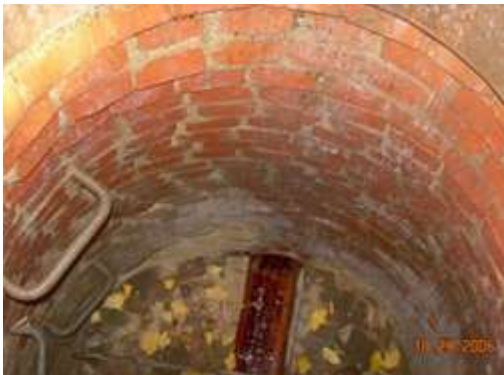
Defect

Chimney / Frame Adjustment ☒ Exists Material: **Brick** ☐ Parged Height: **6** (in.)
Condition: ☒ Sound ☐ Cracked ☐ Root Intrusion ☐ Loose Brick ☐ Deteriorated
Infiltration: ☐ None ☒ **Joint** ☐ Cracks ☒ **Mortar** ☐ Roots ☐ Wall

Corbel Material: **Brick** ☐ Parged Type: **Concentric/Eccentric**
Condition: ☒ Sound ☐ Cracked ☐ Root Intrusion ☐ Loose Brick ☐ Deteriorated
Infiltration: ☐ None ☐ Joint ☐ Cracks ☒ **Mortar** ☐ Roots ☒ **Wall**

Barrel Material: **Brick** ☐ Parged
Shape: **Circular** Diameter: **42** (in.) Length: (in.)
Condition: ☒ Sound ☐ Cracked ☐ Root Intrusion ☐ Loose Brick ☐ Deteriorated
Infiltration: ☐ None ☐ Joint ☐ Cracks ☒ **Mortar** ☐ Roots ☒ **Wall**

Bench debris. Adjustment, Corbel, and Barrel infiltration.

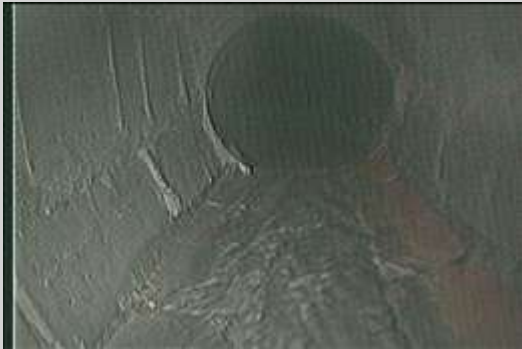
8 in. Circular Gravity Sewer Pipe Out @ 12 O'Clock

Comments **The I6 pipe seal is not flush to the pipe.**

Infiltration: **None** Pipe Seal Cond: **Cracked**

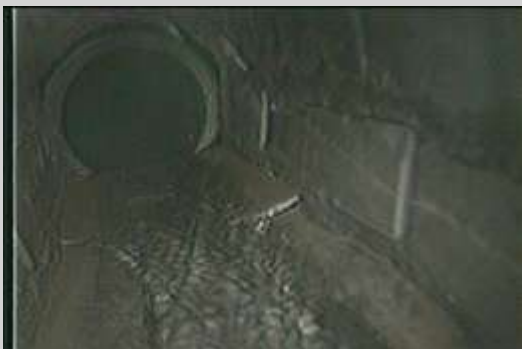
8 in. Circular Gravity Sewer Pipe In @ 6 O'Clock

Infiltration: **Evidence** Pipe Seal Cond: **Unknown**
